Manhole Inspection Summary

Manhole # S67U__005MH

Insp Date: **3/11/08 1:45 PM**

Location Address: **6301 Seaforth St.**

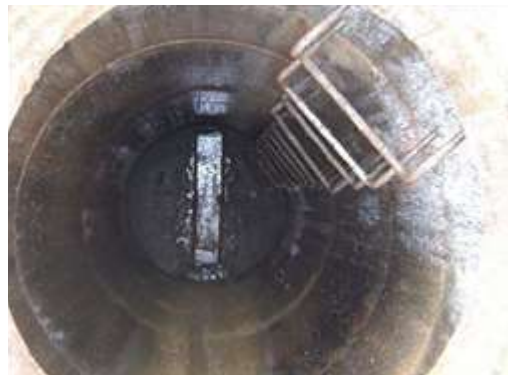
Top View

Infiltration: ☐ None ☒ **Joint** ☐ Cracks ☐ Mortar ☐ Roots ☐ Wall

Surcharge ☒ **Evidence Of Surcharge** Depth: **2** (ft.) ☐ Active Surcharge Present

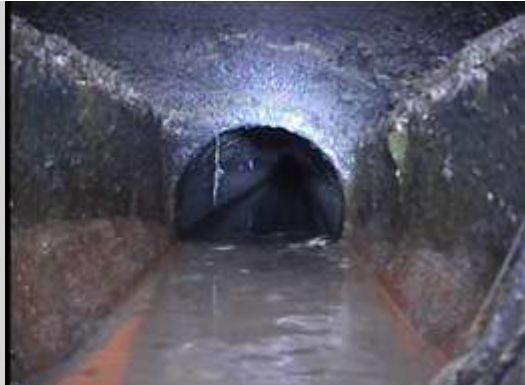
12 O'Clock Outflow

8 in. Circular Gravity Sewer
Pipe Out @ 12 O'Clock

Pipe Height: **8.4** (in.) Rod and Bar (Angled)
Pipe Material: **Clay** ☐ Pipe Lined
Invert Depth: **16.46** (ft.) Flow Characteristics: **Fast**
Deposits: ☐ None ☐ Mud ☐ Grassy ☒ **Debris** ☐ Grease
Silt Depth: **0.25** (in.) Deposits Extent: **Light**
Infiltration: **None** Pipe Seal Cond: **Sound**

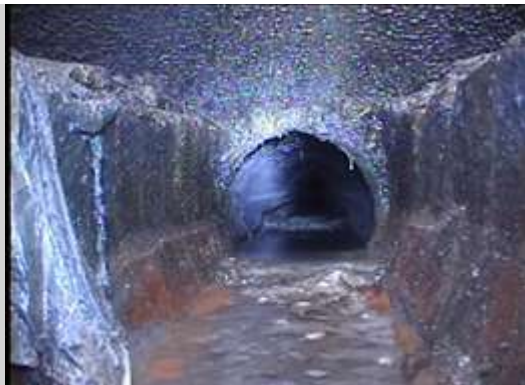
6 O'Clock Inflow

8 in. Circular Gravity Sewer
Pipe In @ 6 O'Clock

Pipe Height: **8.4** (in.) Rod and Bar (Angled)
Pipe Material: **Clay** ☐ Pipe Lined
Invert Depth: **16.38** (ft.) Flow Characteristics: **Fast**
Deposits: ☐ None ☐ Mud ☒ Grassy ☒ **Debris** ☐ Grease
Silt Depth: **1** (in.) Deposits Extent: **Medium**
Infiltration: **None** Pipe Seal Cond: **Sound**
